1280

January 31, 2001

**Summary Geotechnical Report: Post-construction  
SR 443 (Delaware Avenue) Landslide at Normans Kill  
Elsmere (Bethlehem), NY**

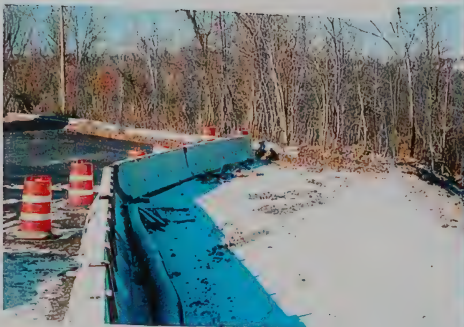
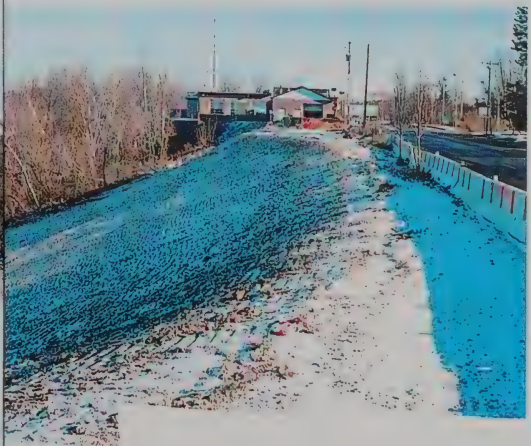
The evaluation of mitigation measures is based on the conditions observed during the December 9<sup>th</sup> reconnaissance. No stability analyses were performed. Photographs 1 through 18 (attached) show the observed conditions. Photo 1 shows a panoramic view of the landslide from Delaware Avenue looking north to the Normans Kill stream. The subsequent permanent earthwork has generally buried the initial emergency measures. The riprap along the realigned stream channel is now being covered with soil (for non-geotechnical reasons). The counterberm filling of the interim stream channel, in addition to the slide debris in the original stream, has added significantly more resistive weight to the slide toe. The slope of the counterberm surface is gentle to promote surface drainage (about 3% slope), and together with the riprap in the relocated stream channel should provide a stable stream bank. Photos 2, 3, and 4 show various views of the counterberm and realigned stream channel.

The final buttress was completed using light-weight pumice rock fill and is generally stable in appearance, except for local runoff erosion near the west end (refer to Photos 1 and 5). Diverting the surface runoff flow could mitigate the surface erosion by piping the collected water away from the steep slope. Alternatively, the erodable slope could be reinforced by installing a geosynthetic erosion control mat made specifically for runoff conditions.

PHOTO 1: PANORAMA OF SLIDE AREA LOOKING EAST TOWARDS DELAWARE AVENUE.

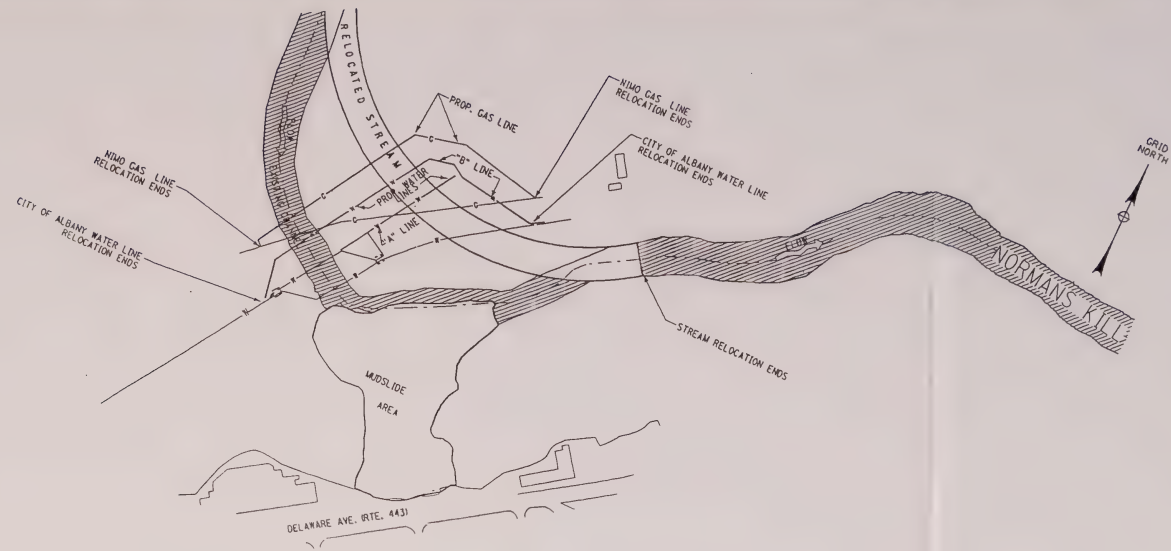
# SITE PLAN

(FROM SHEET 10 OF CONSTRUCTION PLANS)

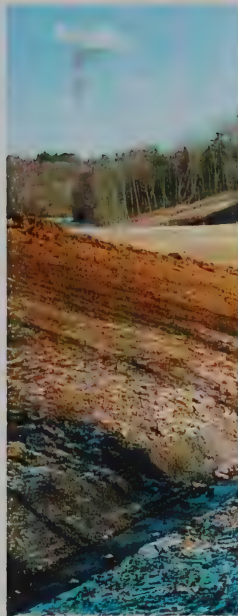
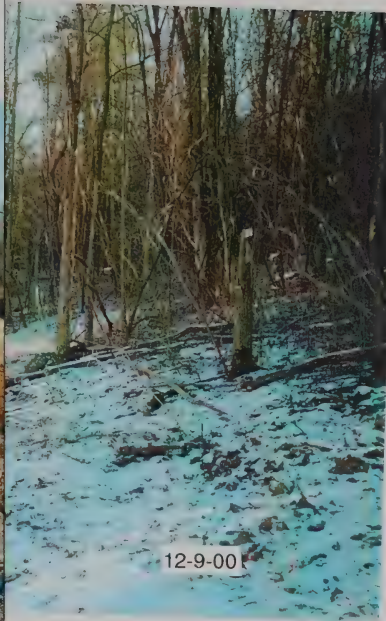
PHOTO 2: LOOKING EAST. NOTE OLD SLUMP FEATURES IN TREED AREAS. NEW COUNTER BERM FILL PLACED AT TOE OF SLIDE. THE FILL COVERS THE FORMER SEEPAGE AND WET AREAS.

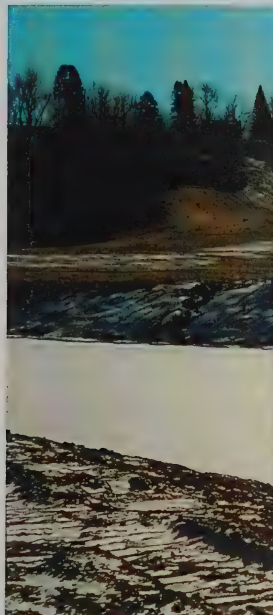
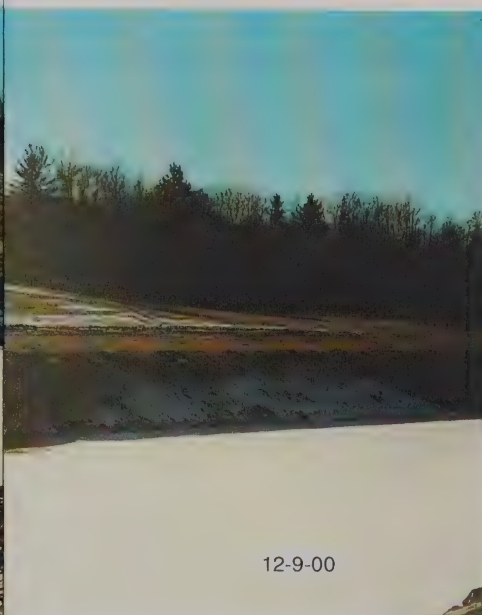
PHOTO 3: LOOKING SOUTH AT LANDSLIDE. NEW REALIGNED NORMANS KILL STREAM CHANNEL IN FOREGROUND. NOTE THE FLAT SLOPE FORMED BY THE COUNTER BERM. THE ORIGINAL STREAM CHANNEL WAS LOCATED BEYOND THE PARKED VEHICLES.

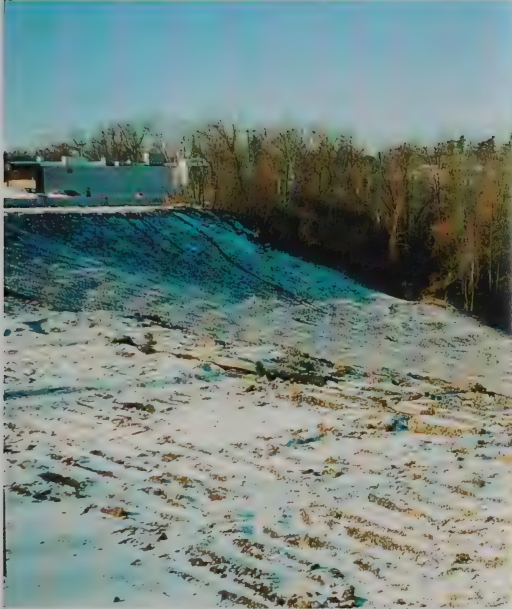
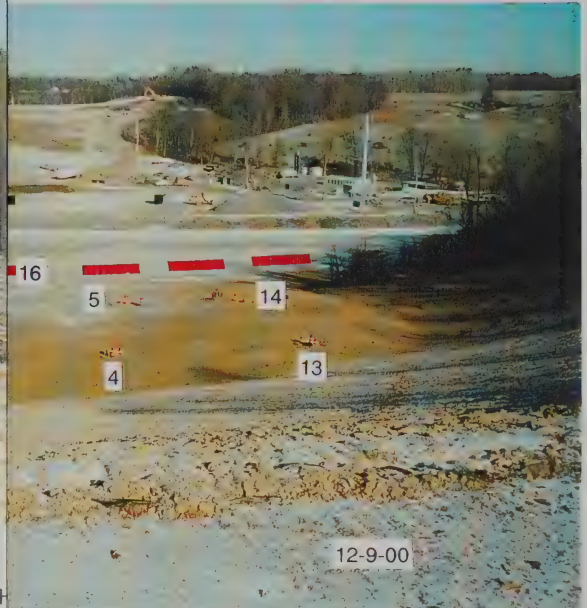
PHOTO 5: LOOKING WEST AT SLOPE TO NORTH OF ALBANY MEDICAL CENTER. NOTE THE OLD SLIDE FEATURES IN TREED AREA. HEADSCARP AREA WAS BUTTRESSED WITH ROCK AND PUMICE, AND IS NOW COVERED WITH SOIL FOR REVEGETATION. NOTE THE EROSION RILL NEAR THE WEST END OF THE UPPERSLOPE, WHERE CONCENTRATED SURFACE RUNOFF IS OCCURRING. CONSTRUCTION EQUIPMENT TO THE NORTH IS WORKING ON THE ALBANY WATER PIPELINE.

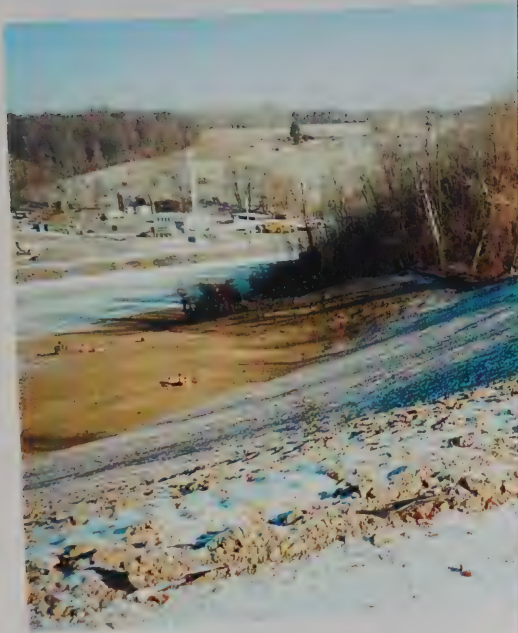
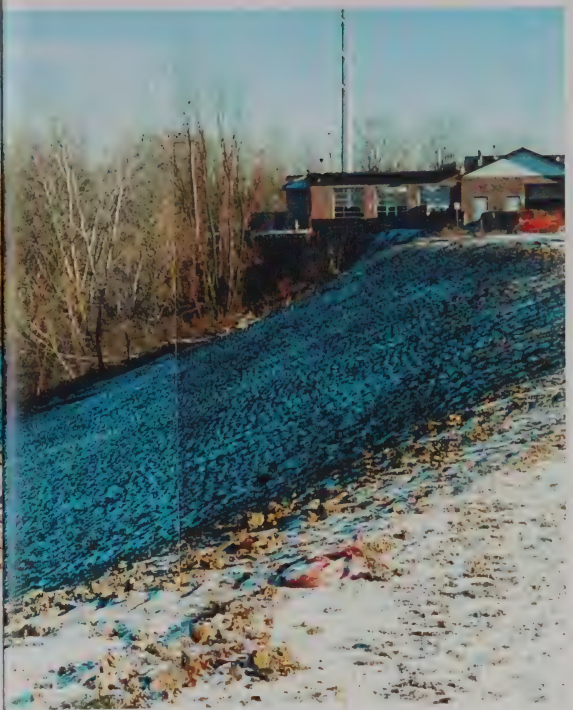
PHOTO 7: LOOKING EAST. EAST SIDE OF LANDSLIDE WITH JIFFY LUBE IN BACKGROUND. NOTE THE ANCIENT SLUMP FEATURES IN TREED AREA AND COUNTER BERM ON LEFT.

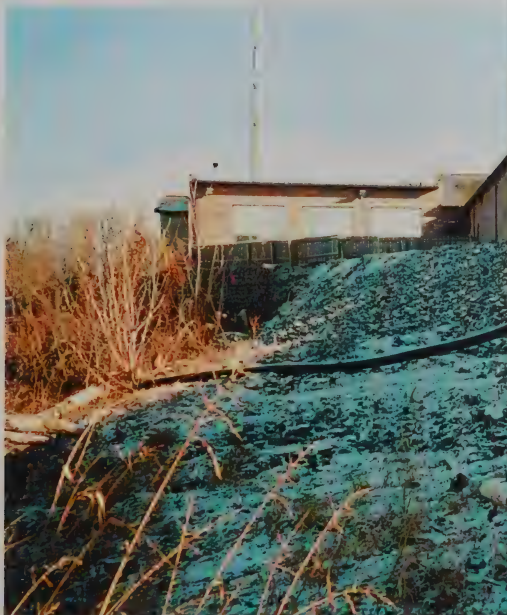
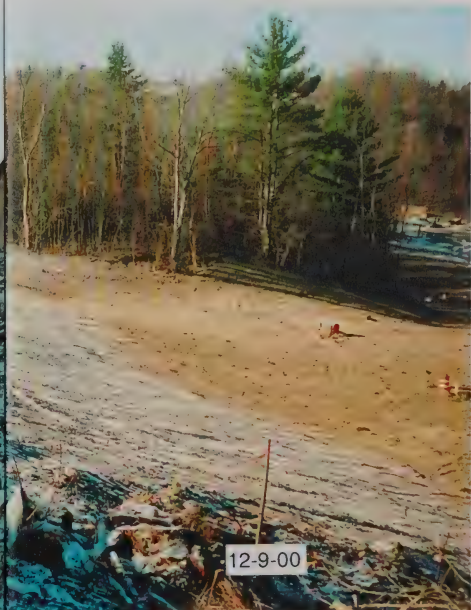
PHOTO 9: LOOKING EAST AT JIFFY LUBE. NOTE DISCHARGE PIPE. ROCK FILL REPLACED THE WESTERLY SECTION OF GABION WALL.

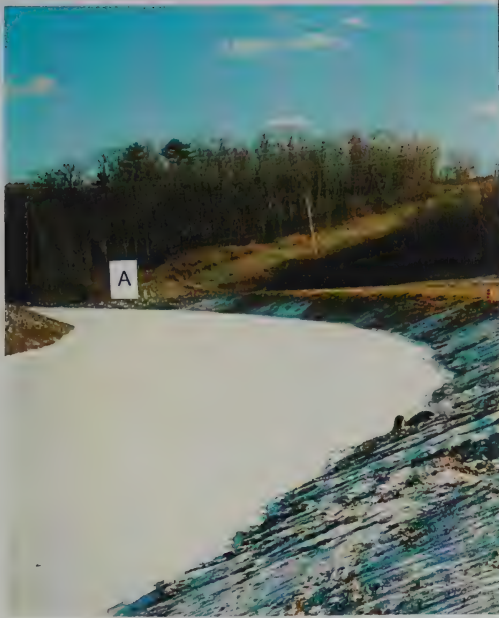
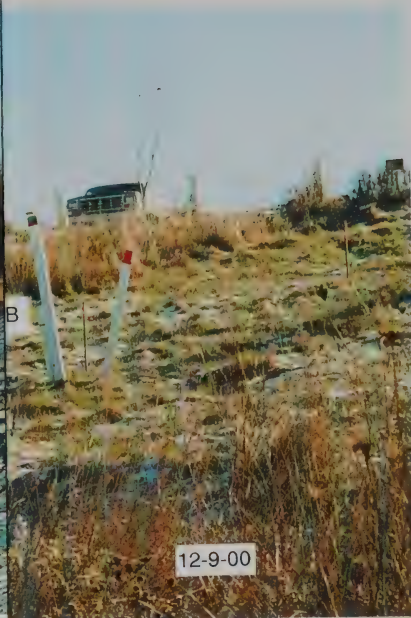
The ground slopes below the Hoffman's Jiffy Lube shop, and the Powerline easement to the east, exhibited less wetlands / seepage than what was observed in May and June. The survey monitoring data provided by the Jiffy Lube owner was limited to a few dates. There was no observable evidence of recent slide cracks or slumping. The counterberm and riprap placed at the stream bank should add resistance to the toe of this slope and make it more stable than before. Photos 7 through 10 show features at the east edge of the slide and at the slope below the Jiffy Lube. Data has not been received for the monitoring points in the Powerline easement. Photos 11 through 14 show slope features and improvements (riprap) made near the Powerline easement.

PHOTO 11: LOOKING SOUTHEAST. COUNTER BERM PLACED AGAINST TOE OF LANDSLIDE (RIGHT FOREGROUND). POWERLINE EASEMENT IN LEFT CENTER. JIFFY LUBE UPPER RIGHT. REALIGNED NORMANS KILL STREAM IN LEFT FOREGROUND.

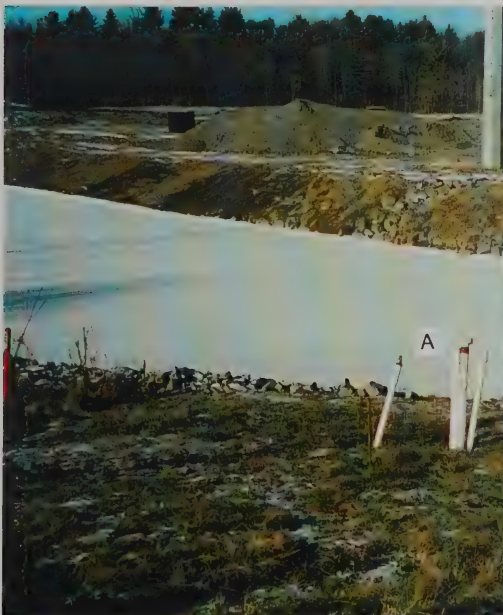
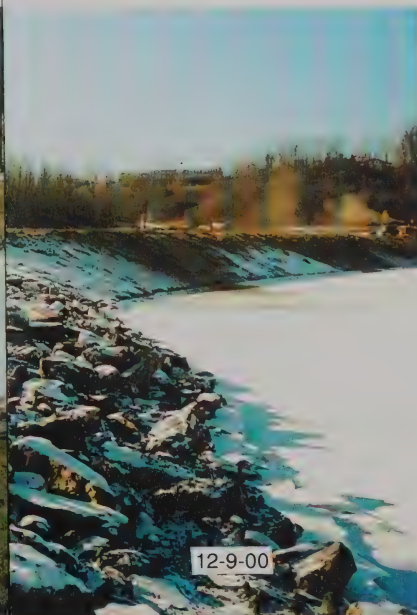
PHOTO 13: WHITE PIPES (A ON PHOTOGRAPH) MARKING GAS PIPELINE EASEMENT. NOTE NEW RIPRAP PROTECTION BOTH SIDES OF STREAM.

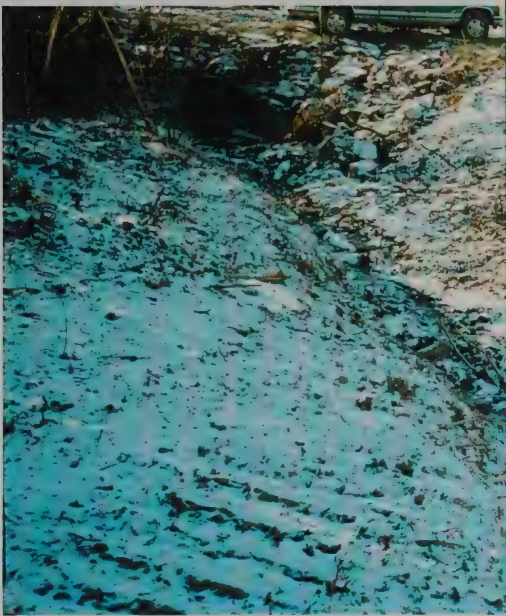
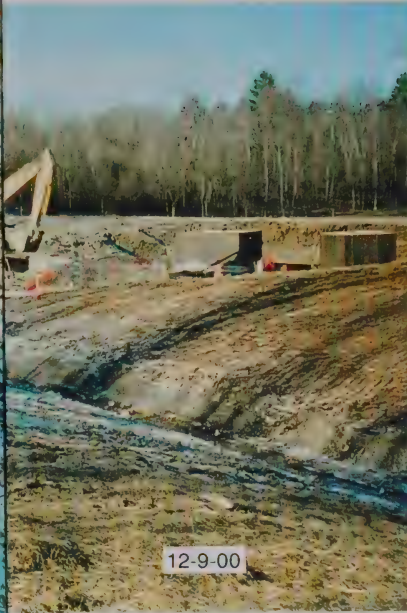
PHOTO 15: LOOKING EAST AT CULVERT NEAR ALBANY WATER PIPELINE EASEMENT.

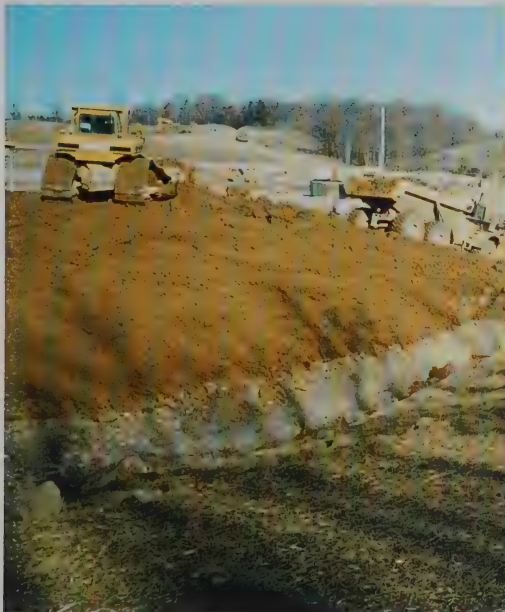
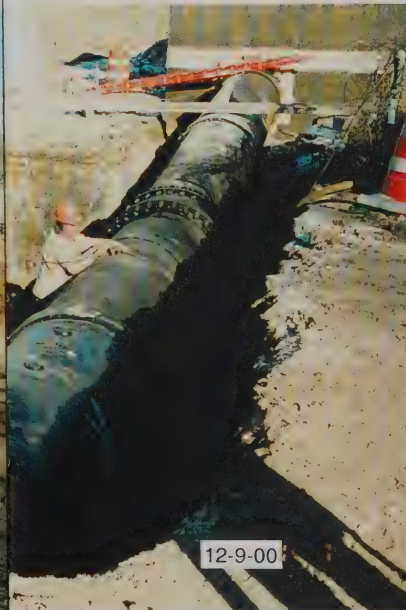
PHOTO 17: LOOKING NORTHEAST. DRAINAGE DITCH FROM CULVERT NEAR ALBANY WATER PIPELINE EASEMENT FLOWS THROUGH NEW COUNTER BERM PLACED AGAINST SLIDE TOE.
